ADA Self Evaluation and Pedestrian Accessibility Study

San Juan, Puerto Rico

Prepared for:
Municipality of San Juan

January 20, 2026

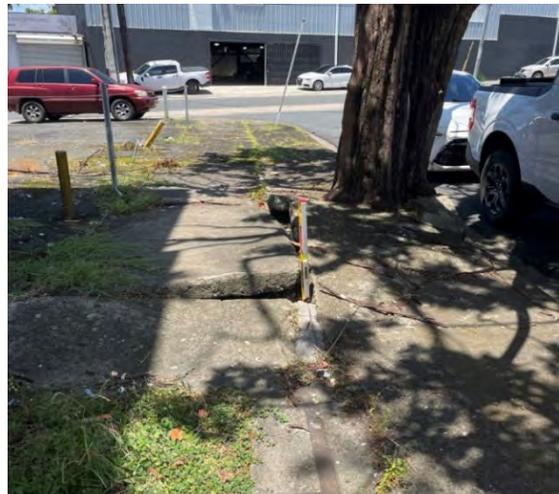
Trip hazard due to tree root damage

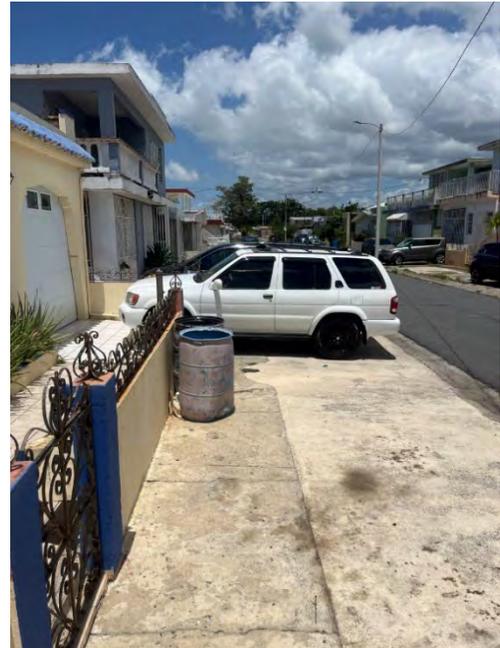
Parked vehicle obstruction on sidewalk along Calle Cali

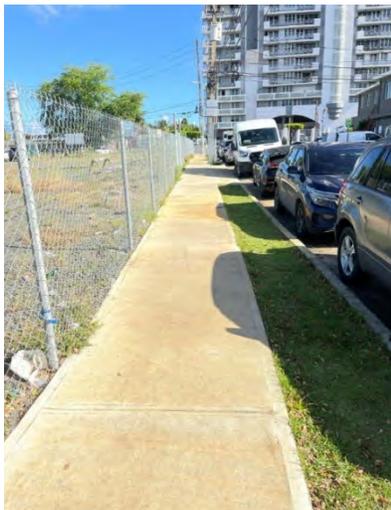
Low distress sidewalk

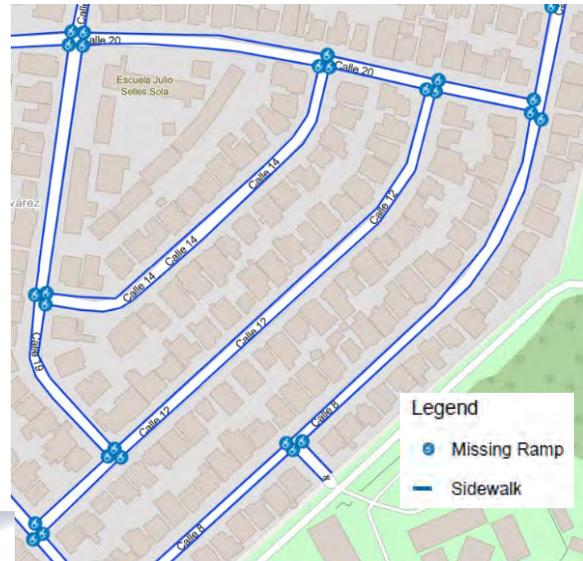
Example intersections and 'sidewalk islands' with missing ramps.

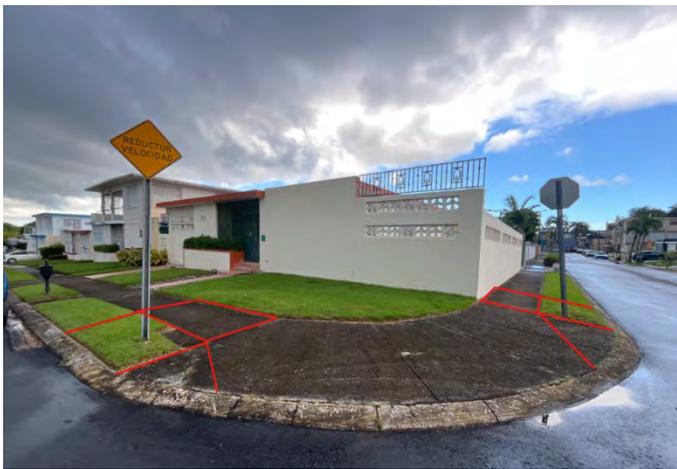
Easy to construct 'Maintenance' type ramps in Reparto Universitario

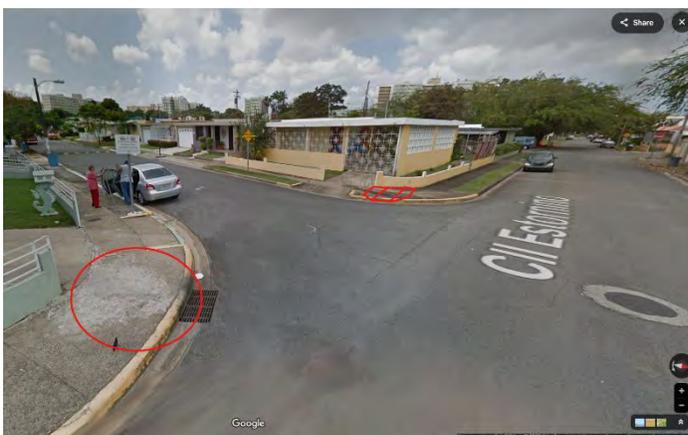
'Engineered' ramp due to near proximity of driveway and drainage inlet

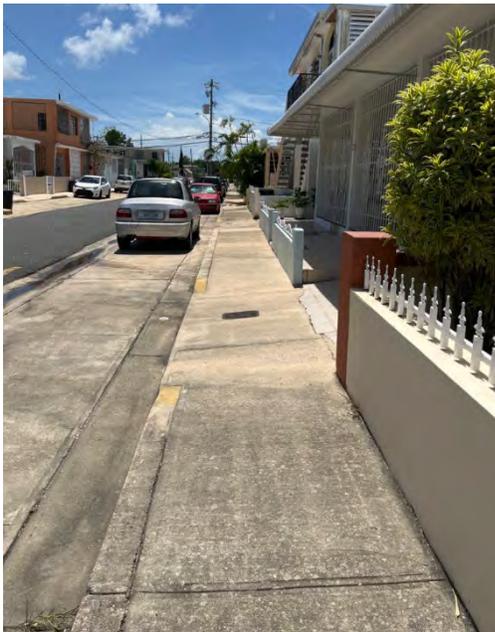
Grade separated sidewalk allows parking and pedestrian access along Calle 10 Noreste

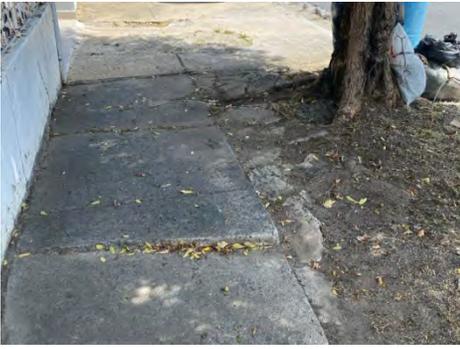
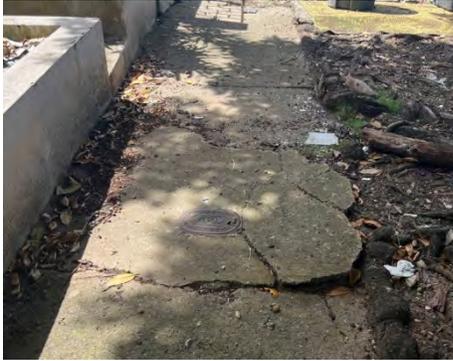
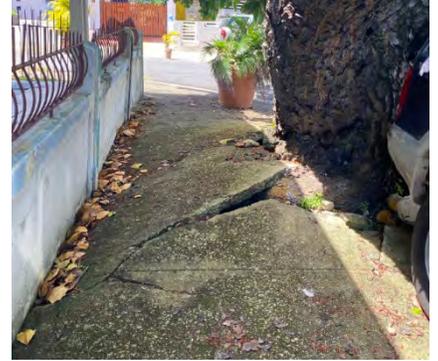
Tree Root Hazard – distorted/faulted/buckled with $\geq 1"$ lift for at least 50% of width

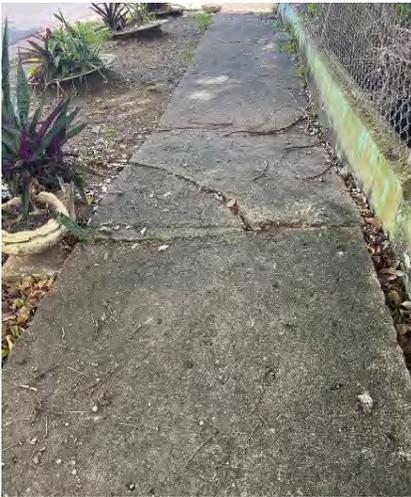
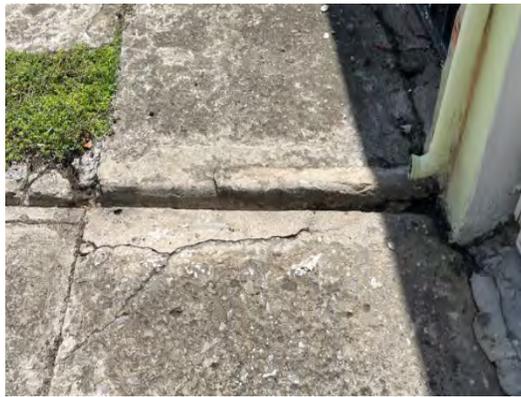
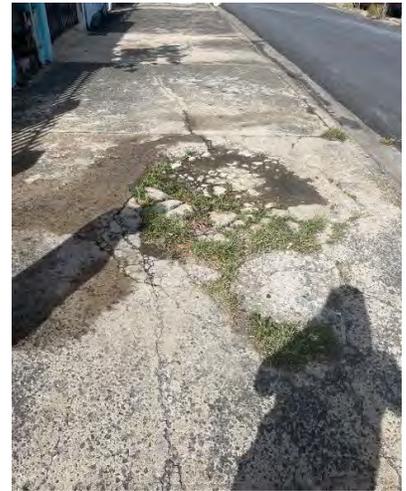
Sidewalk Surface Hazard – $\geq 1"$ faulting on at least 50% sidewalk width, drainage grooves, and/or potholes/missing materials.

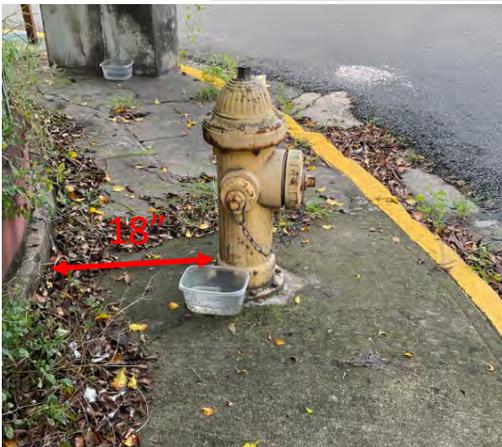
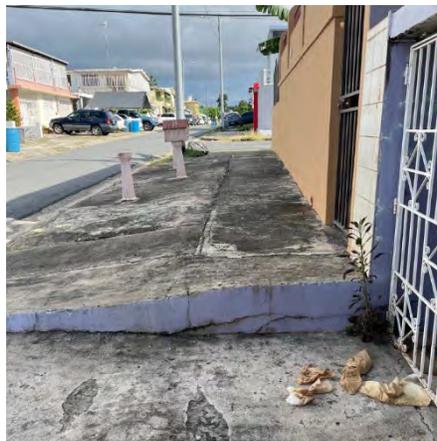
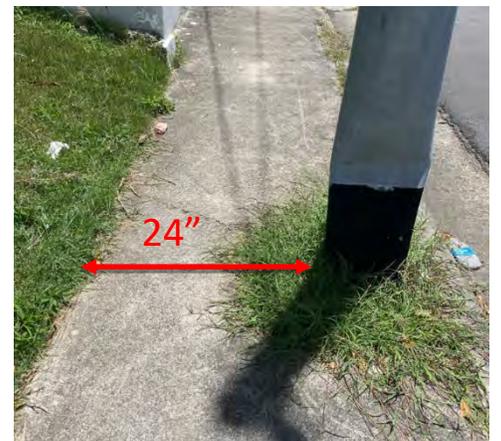
Fixed Pinch Point – path of travel is $< 36"$ wide due to hard obstruction.

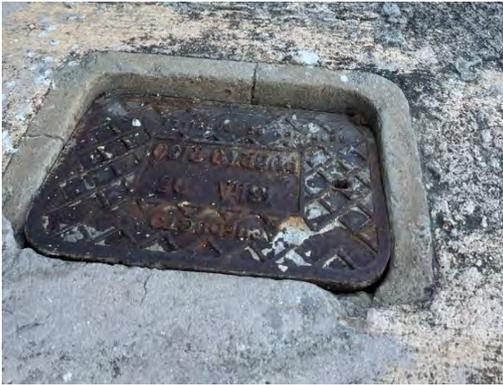
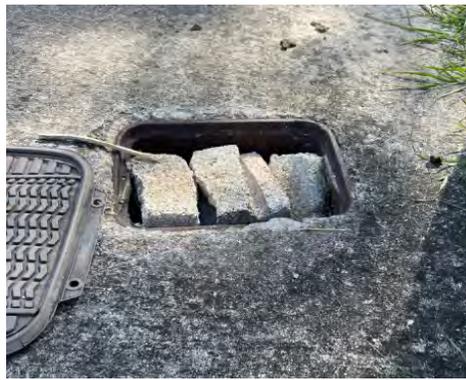
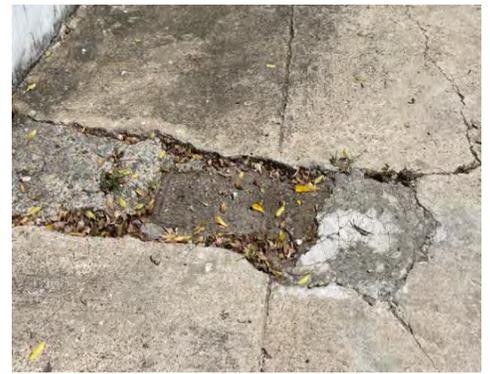
Gate Hazard – any ≥ 1 " surface related hazards due to gates and/or other utility structures.
