ADA Self Evaluation and Pedestrian Accessibility Study

San Juan, Puerto Rico

Prepared for:
Municipality of San Juan

January 20, 2026

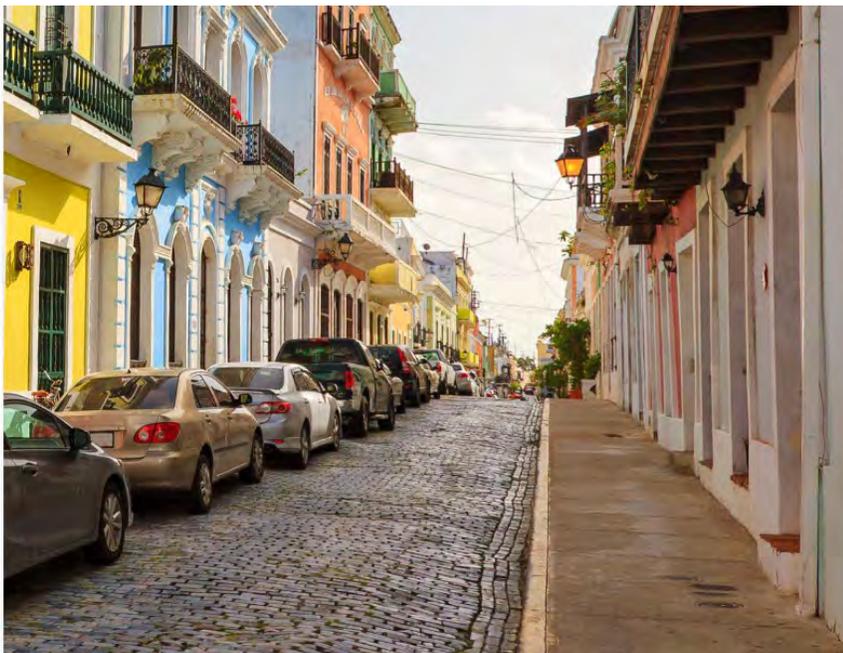
Cobblestone street with cement concrete sidewalk in Old San Juan.

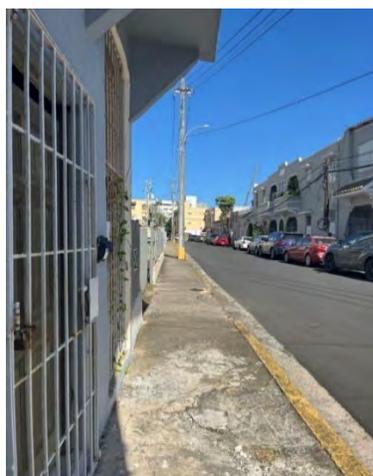
Moderate distress sidewalk

1. 0-20% = Low Distress - Do Nothing/Continue to Monitor
2. 21-50% = Moderate Distress - Localized Sidewalk Repairs
3. 51-100% = High Distress – Full Sidewalk Reconstruction

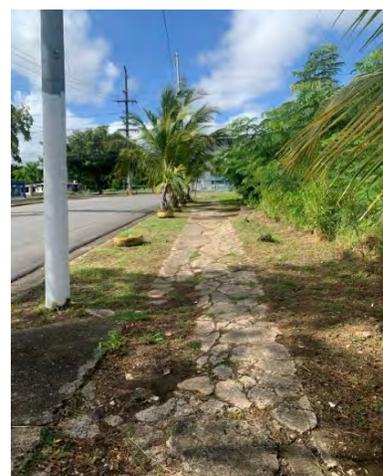
High distress sidewalk

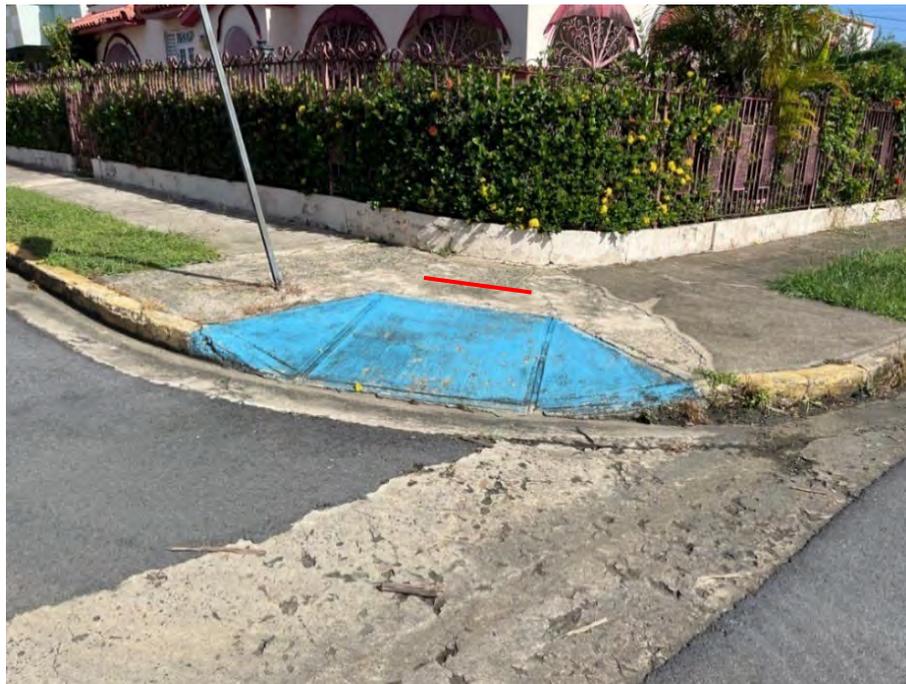
Note: Figure 4 excludes ramps where no level landing was present. The distribution of landing slopes is not desirable as a significant portion of the ramps have landing slopes above the maximum ADA compliant slope. There are also a significant number of ramps which have landing slopes exceeding 5% (as can be seen by the top red bar in Figure 4), which significantly impedes accessibility. Below is an example of this instance. Though in some cases, throughout the City there are challenges to accommodate a complaint level landing with topographic constraints along the back of sidewalk such as wall, step, fence or driveway impacting third party property rights.

8.2% Landing Cross Slope

When the landing slope is out of compliance, especially over 5%, the ramp will typically require full reconstruction. As the adjoining sidewalk and ramp planes (apron, flare, etc.) cannot be retained without creating a lip/trip hazard at the interface of adjoining plane surfaces.

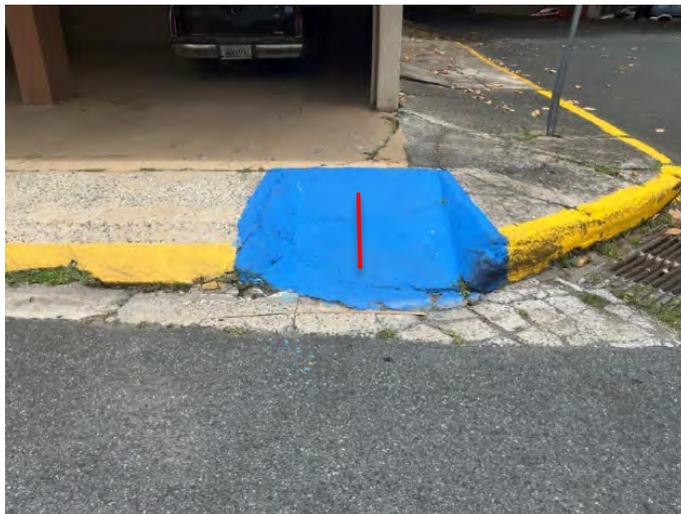
Note: Figure 5 apron running slopes include left- and right-side apron slopes, as recorded on “parallel” and “combination” types of ramps. The distribution of apron slopes city-wide are not desirable as many ramps have slopes greater than the allowable maximum 8.33% compliant ADA slope. While ramps are provided, those with non-compliant apron slopes present a challenge to individuals with mobility disabilities. There are also a significant number of ramps which have apron slopes exceeding 15% (as can be seen by the top red bar in Figure 5). These significantly impede accessibility. Below are some examples of these instances.

23.5% Apron Slope

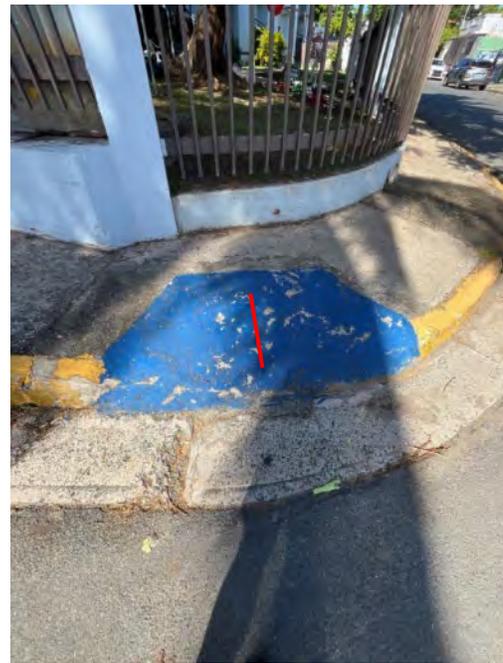
18.3% Apron Slope

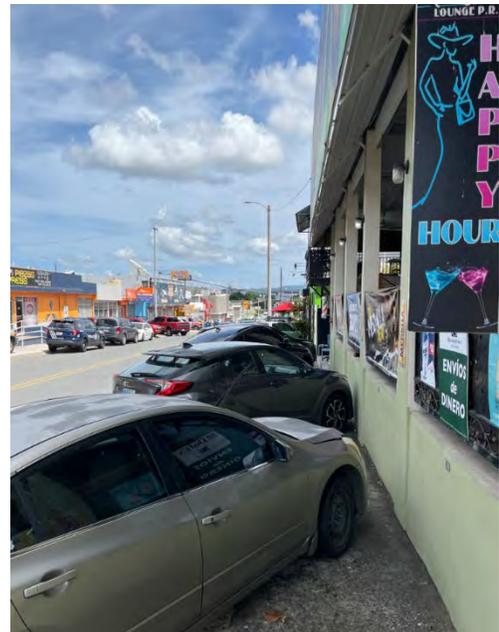
Parking on the sidewalk is a nuanced issue and addressing it may require a balanced approach of policy efforts, public engagement, and creative street design. However, vehicles parked on the sidewalk forces both disabled and abled bodied people out into oncoming vehicular traffic, creating an unsafe condition particularly along the 'Avenidas'.

Off street parking on sidewalk along Avenida Jose de Diego

of vehicular traffic from pedestrians without expensive corridor reconstruction. For example, the Municipality could invest in dedicated markings and signage to discourage people from parking their cars on sidewalks. The Municipality could also consider structured penalties and fees, and increased enforcement in key areas. However, measures should be paired with thorough public outreach to ensure the MSJ's goal to create more pedestrian accessibility is accepted and understood.

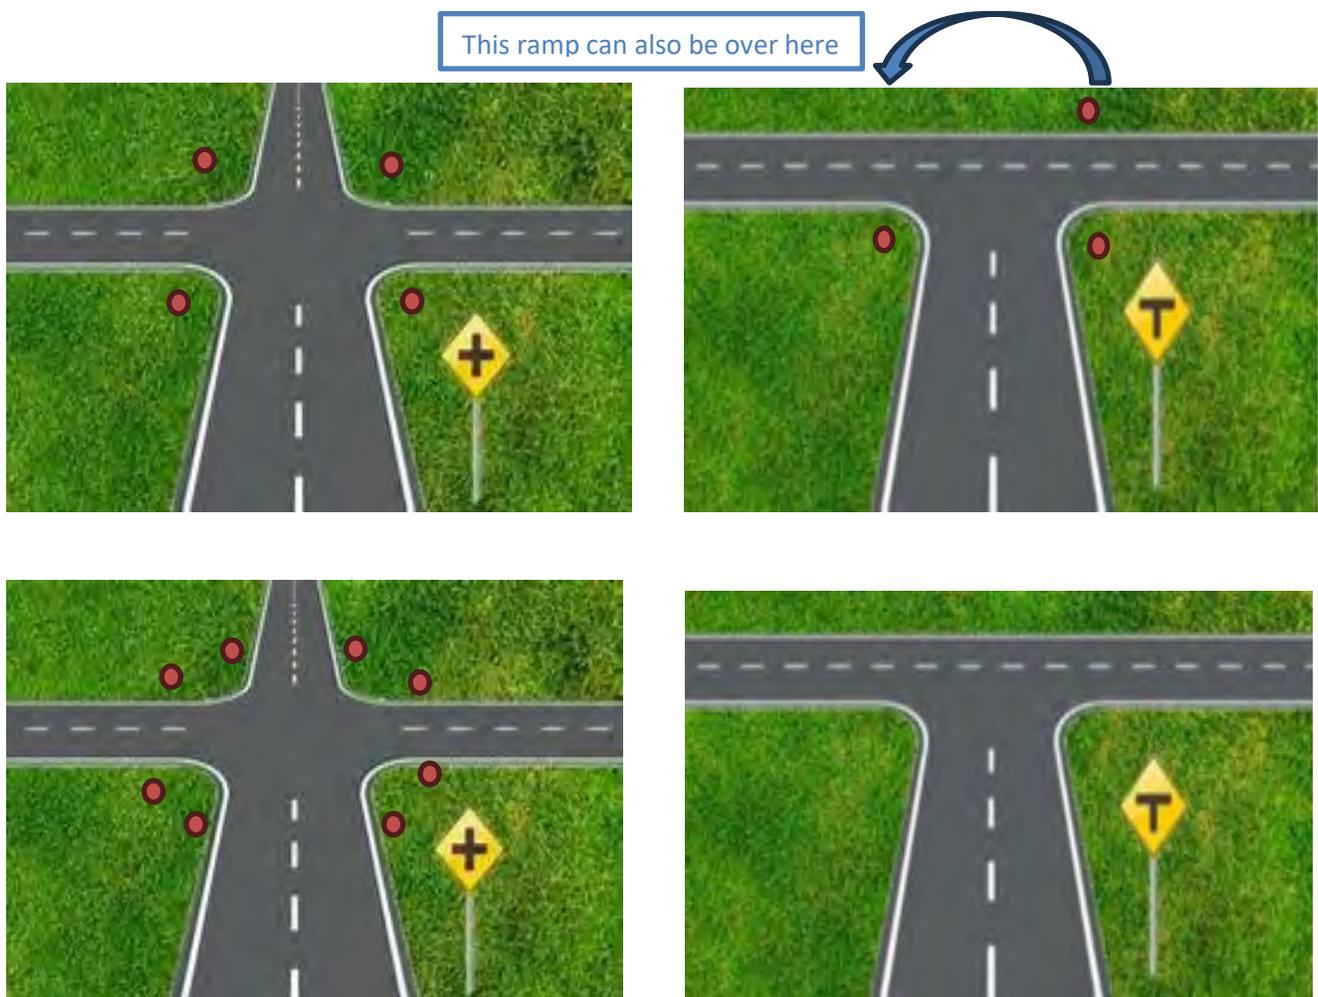
Intersections with Missing Ramps

It is important to note the locations of missing ramps during the preliminary inspection phase or self-evaluation process as it allows the Municipality to assess which areas may be of higher priority for attention. Although the sidewalk will not

be accessible for pedestrians until ramps are installed, missing ramp(s) provide an opportunity to ensure future ramps are identified and designed accordingly.

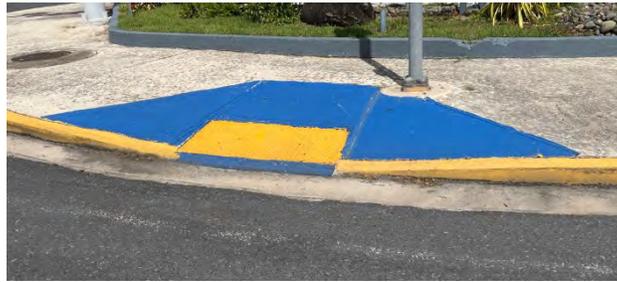
1. Excellent - These ramps have been recently constructed and have no surface damage and good skid resistance.
2. Fair - These ramps show wear but only have insignificant damage such as hairline cracking which has no impact on the overall accessibility of the ramp and fair skid resistance.
3. Poor - These ramps have significant cracks, spalling, or any other damage which affect accessibility of the ramp. Surface has poor skid resistance, probable to slip during wet weather – likely overpainted.

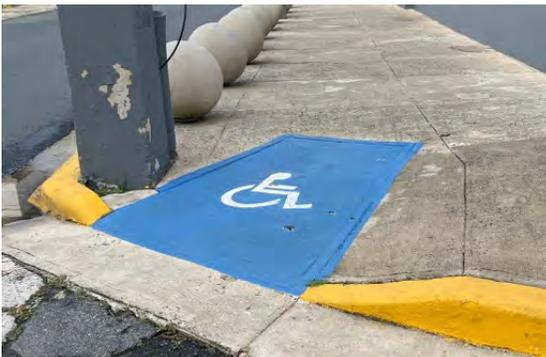
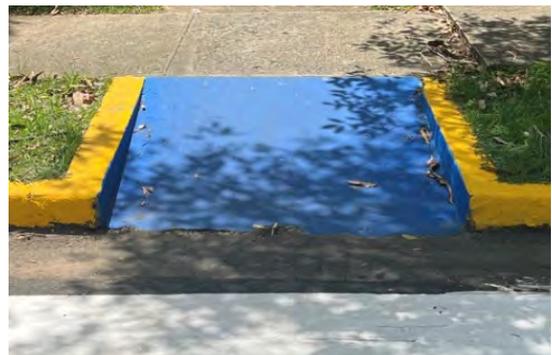
Below are some examples of obstructed flares:

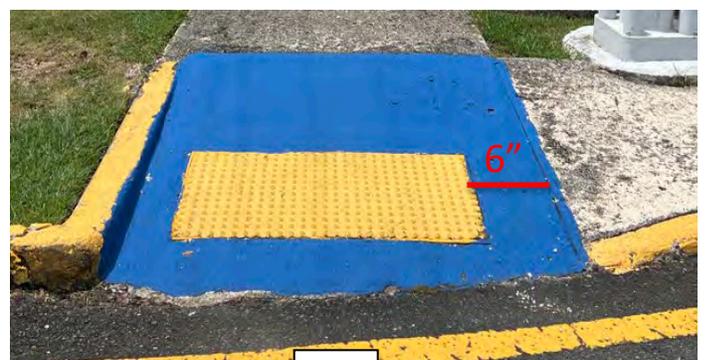
1. Yes (Detectable Warning Panel extends width of ramp, less than 2" between panel and width)
2. No (Detectable Warning Panel does not extend to width of ramp, greater than 2" between panel and width)

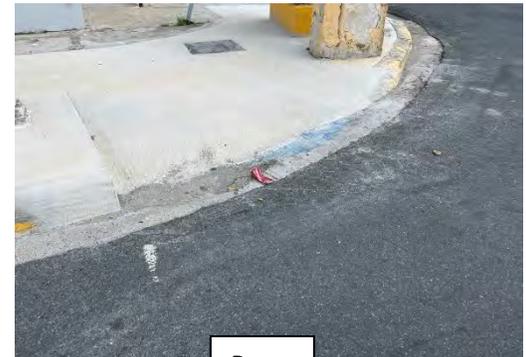
1. Excellent Condition (like new crosswalks with no sign of wear)
2. Fair Condition (crosswalks show wear but are visible)
3. Poor Condition (crosswalks are faded and have low visibility)

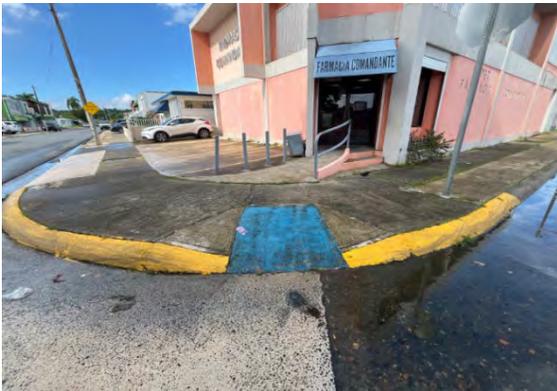
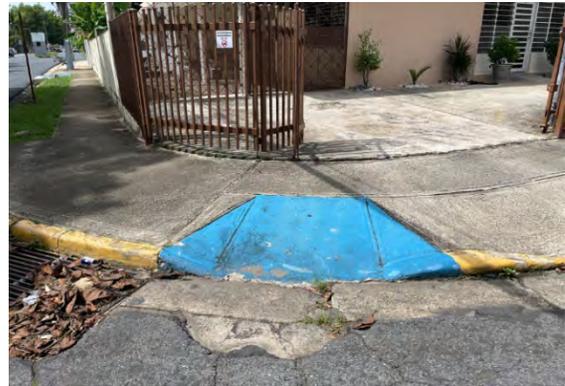
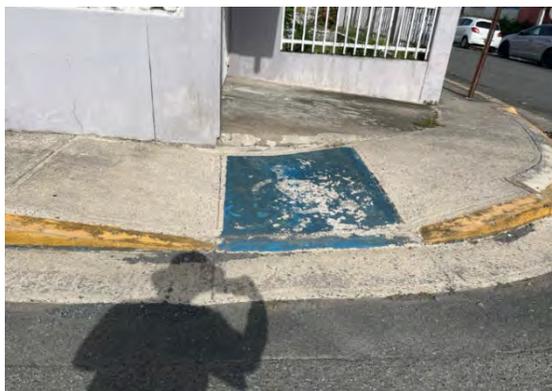
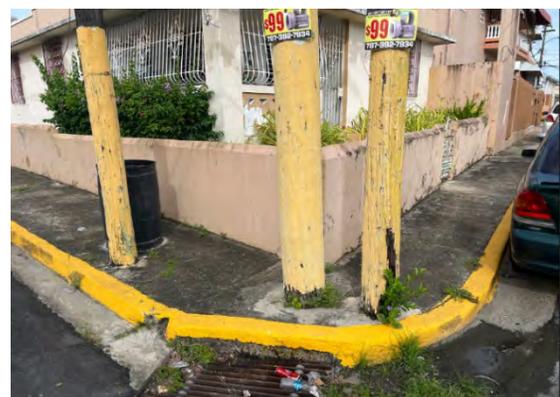
1. Maintenance: Ramps likely could be brought into compliance by repair and/or construction through a maintenance contract, i.e. no survey or engineered plan needed. Construction can start soon. No physical constraints that would require utility relocation, curb modifications, or intersection improvements to be made.
2. Engineered: Ramps have physical constraints, likely would require relocation, extensive curb/sidewalk modification, or intersection improvement. This work would require specialized plan including full survey and design to properly construct and meet with ADA standards. Construction would be part of a long-term plan or project. Below are examples of ramps that are likely needing engineering.

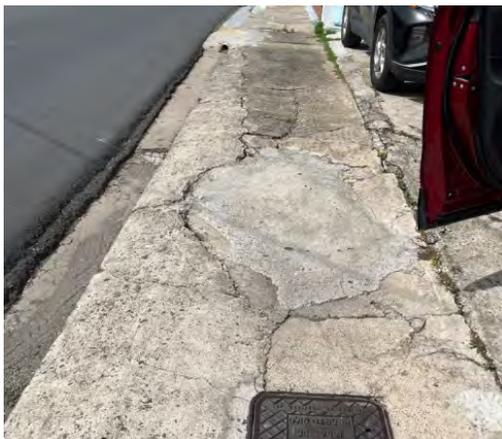
Comment: Homeowner has fallen due to changes in slope.

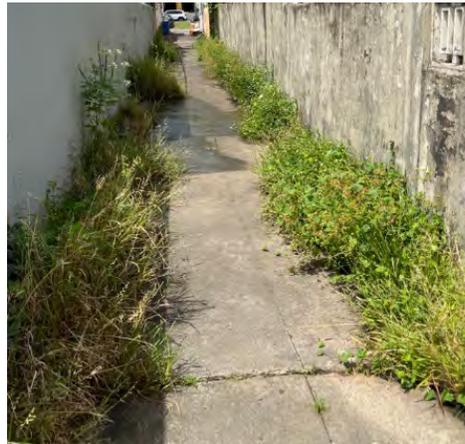
Comment: Homeowners use this sidewalk to get to the hospital, needs maintenance and signs of do not park/block.

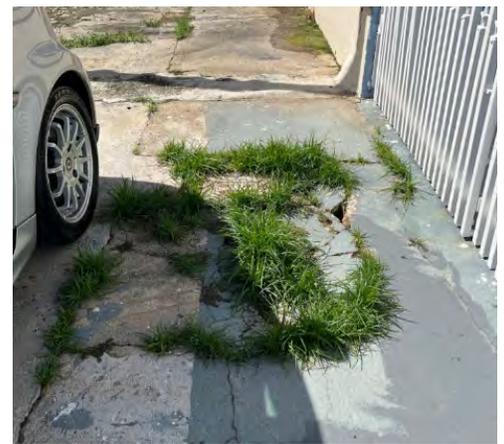
Comment: Elizabeth Santiago Silva says she has a problem in the sidewalk which municipality has not worked on.

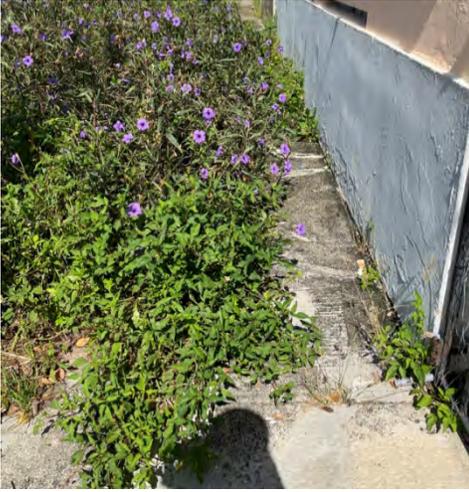
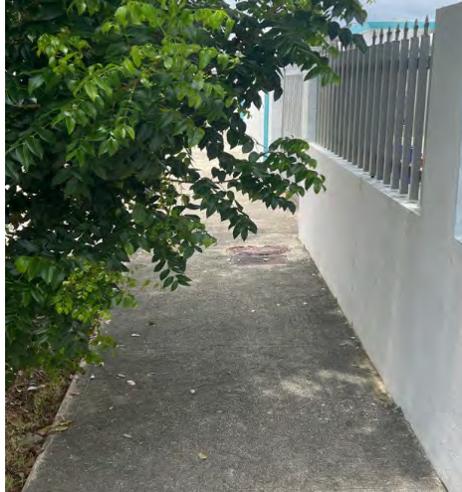
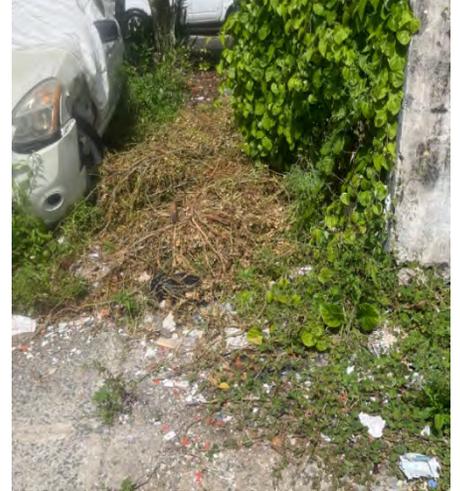
Vegetation – any vegetation barriers that could be corrected with

maintenance.

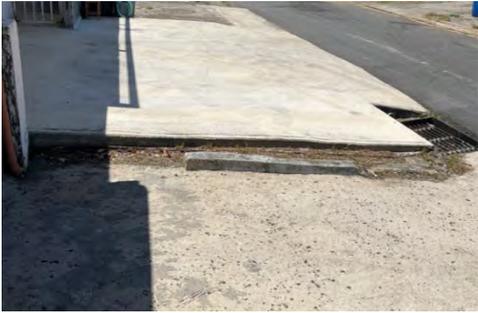
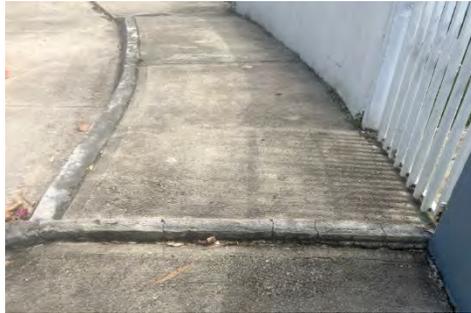
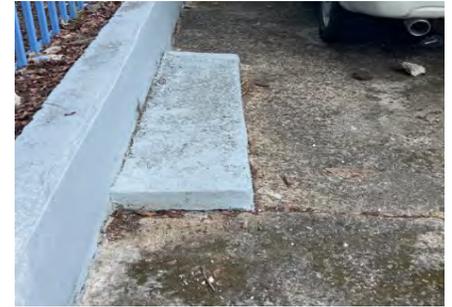
Surface Protrusion – any ≥ 1 " surface protrusions. Note protrusions >6 " along full width of sidewalk are recorded as pinch point.

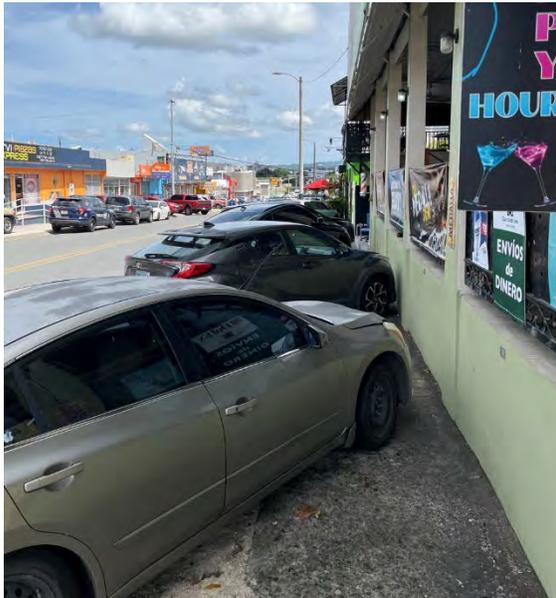
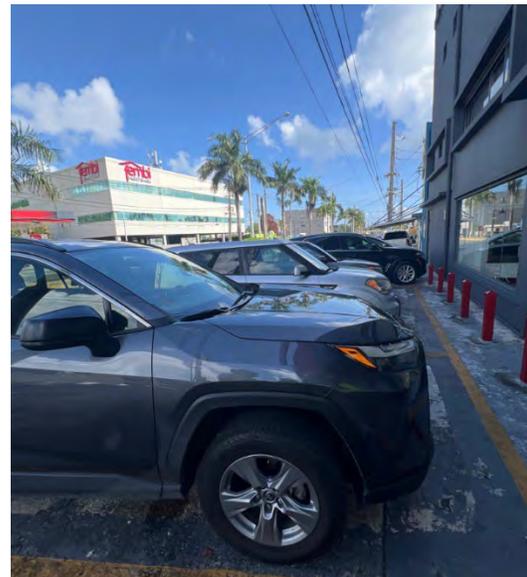
Parked Vehicles

This evaluation form/attribute is intended to determine the limits of how much of a given sidewalk is used for vehicle parking along all Avenues. The inspector determines how much of the sidewalk is occupied by parked vehicles then creates a polyline on Field Maps to show limits of where parked vehicles are blocking the sidewalk or primary accessible path of travel.

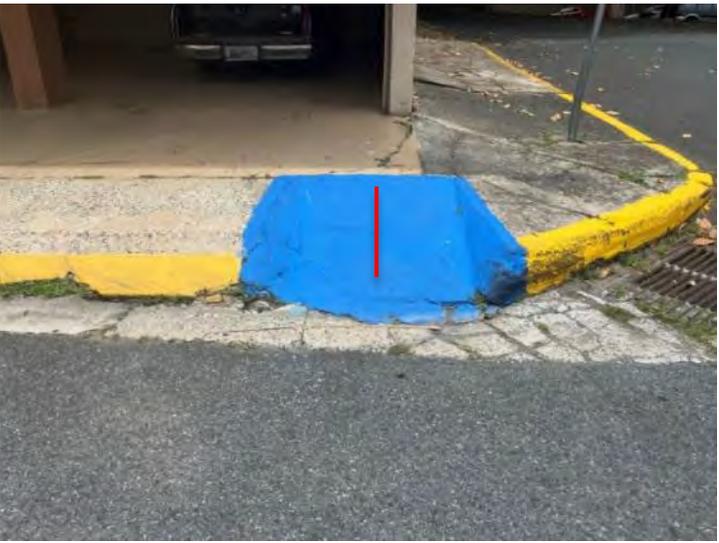
- **Frequent issue:** aprons too steep
- **71%** of ramps failed compliance standards

23.5% Apron Slope

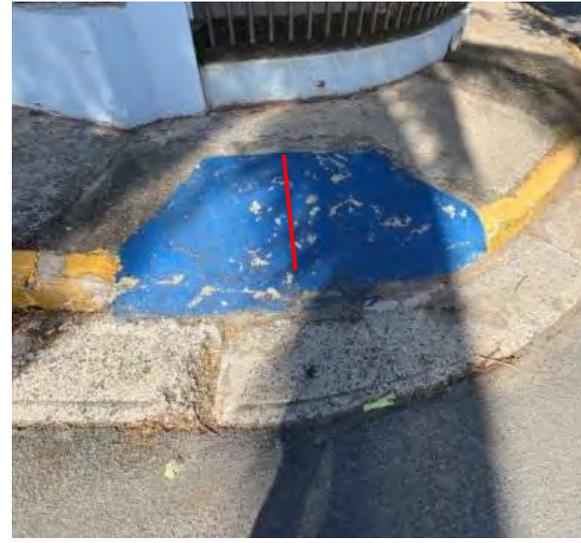
18.3% Apron Slope

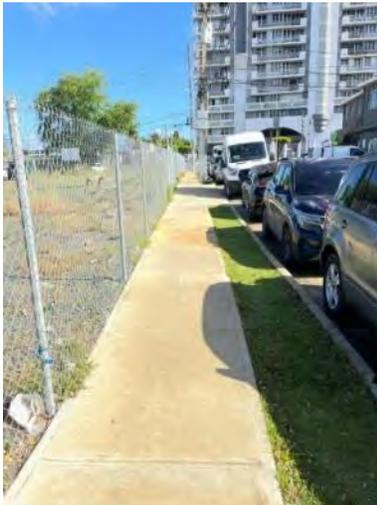
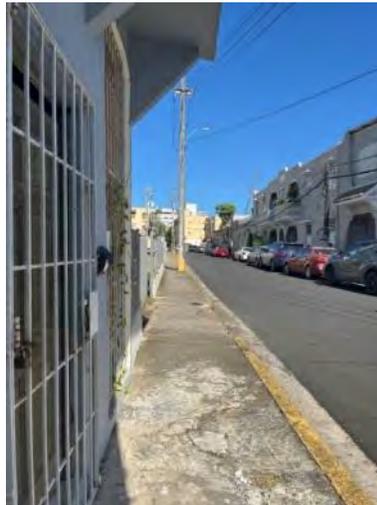
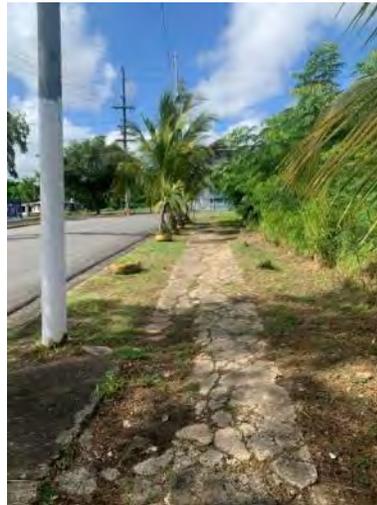
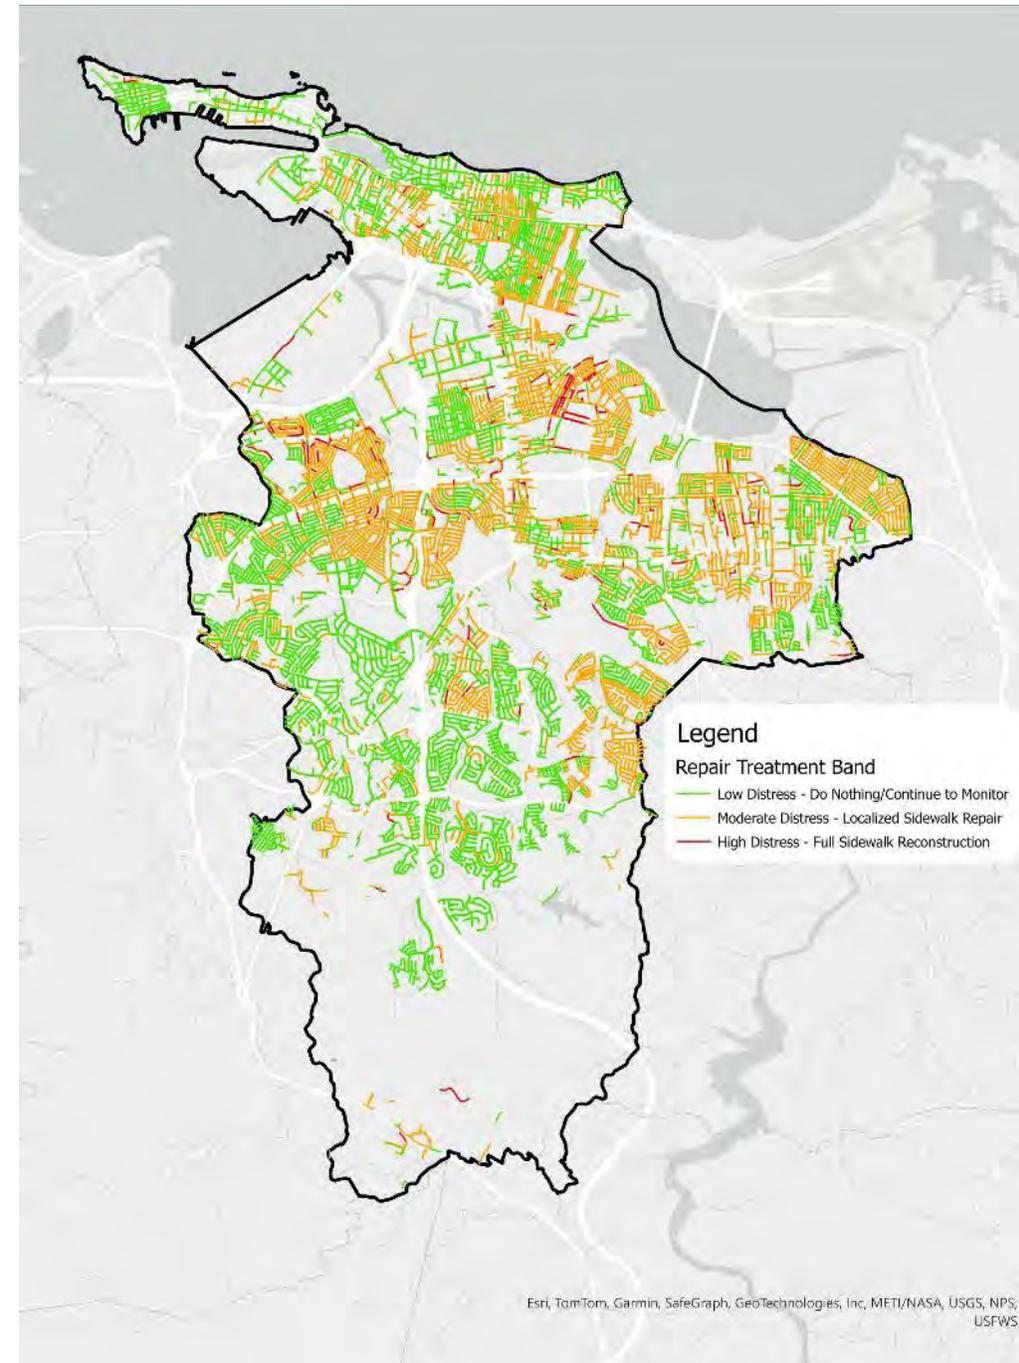
Existing Sidewalk Conditions

- Estimated percentage of damaged area recorded for each segment

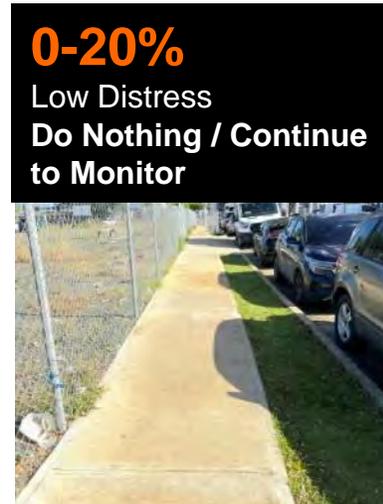
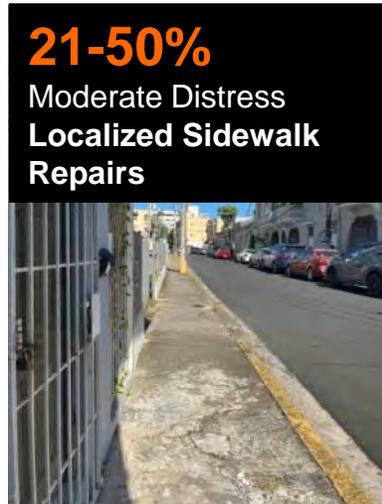
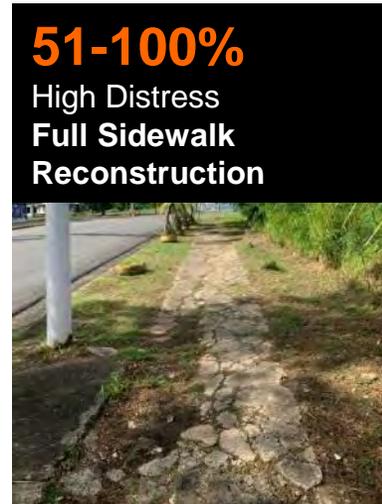
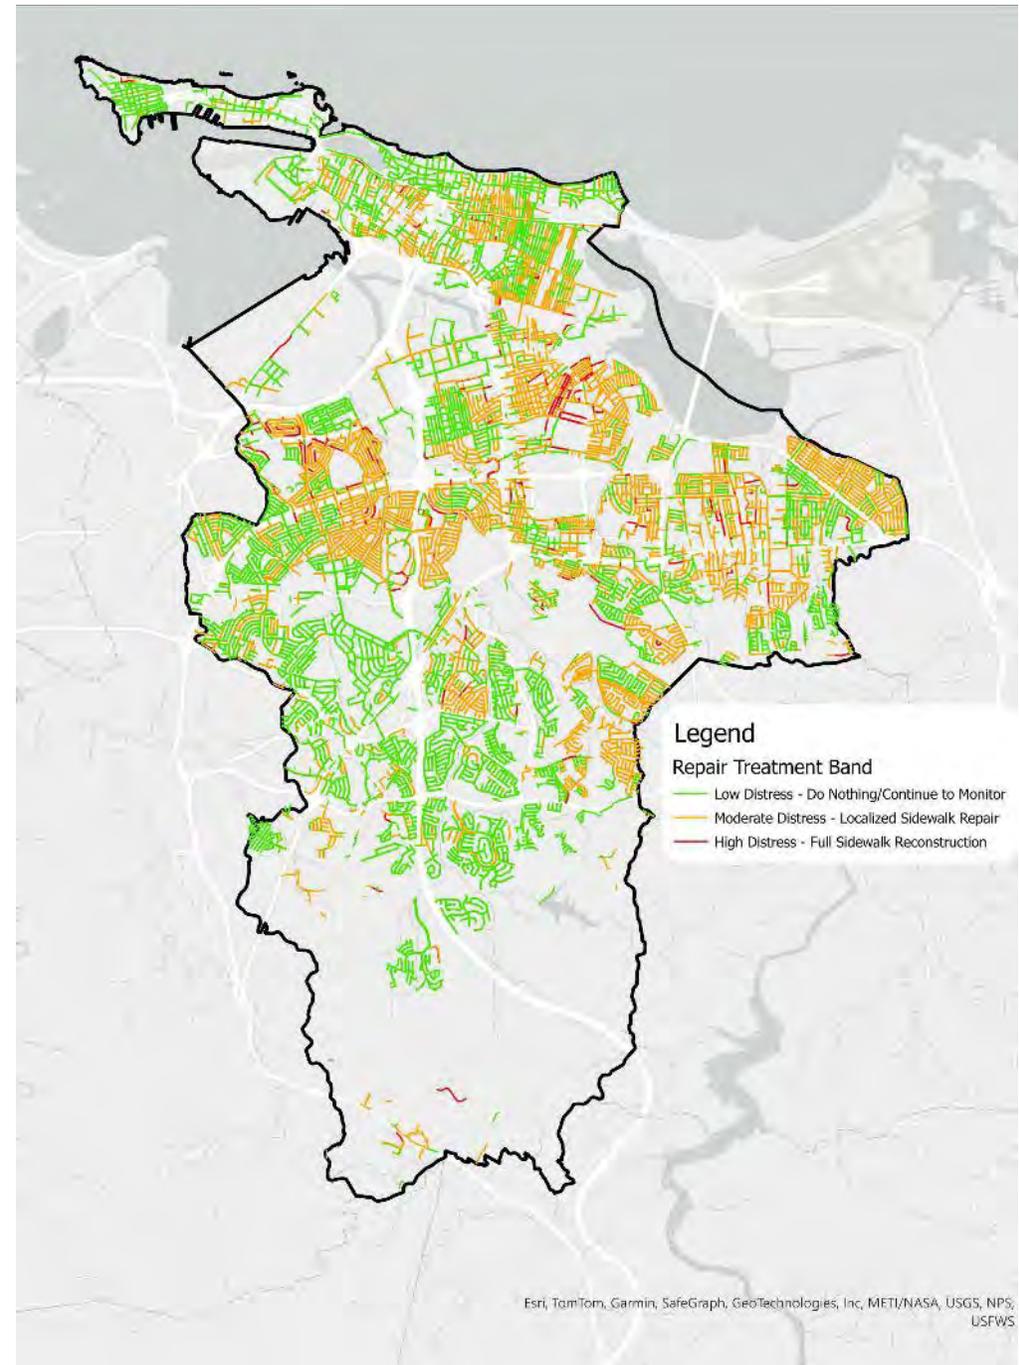
Existing Sidewalk Conditions

- Estimated percentage of damaged area recorded for each segment

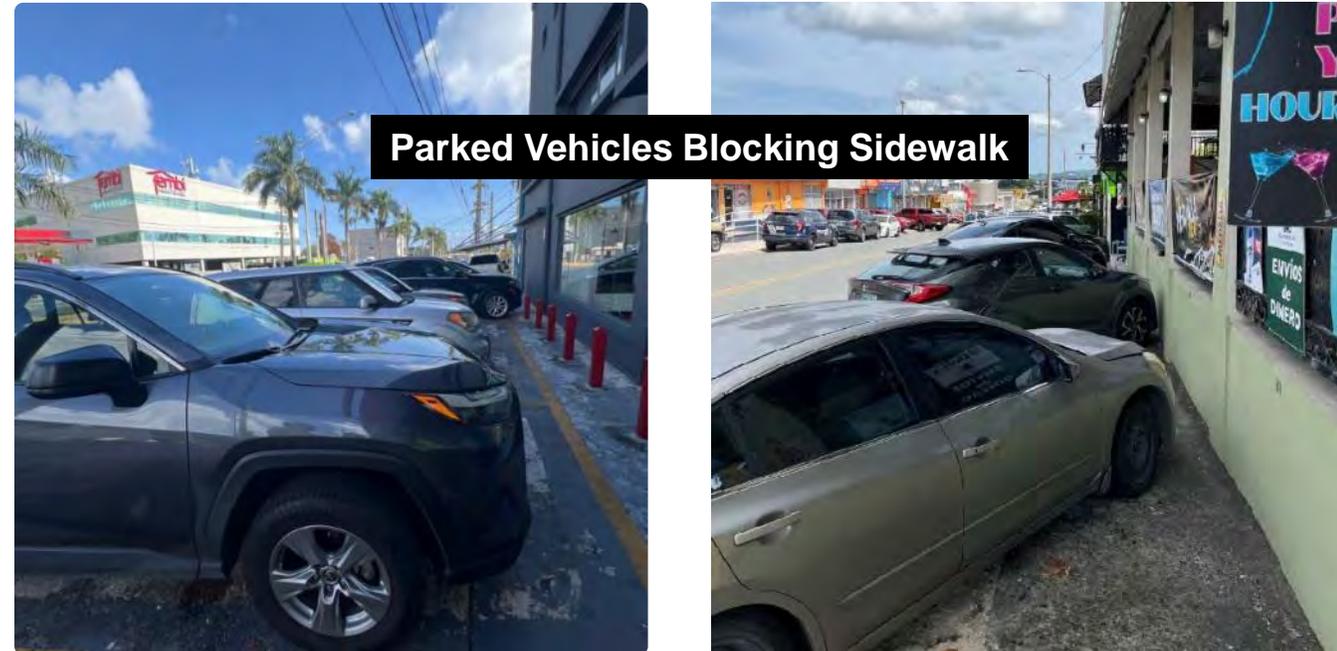
- **8,001 hazards** (<36") identified, measured, and mapped

- Evaluated using:
- **Sidewalk cross-slope**
- **Sidewalk width**
- **Presence of pinch points and trip hazards**

Non-Compliant Sidewalk Accessibility Attribute	Count of Sidewalk Segments
Cross Slope >2.2%	6,375
Sidewalk Width <3'	383
Fixed Pinch Point	1,469
Gate Hazard	1,142
Sidewalk Surface Hazard	1,650
Surface Protrusion	369
Tree Root Hazard	821
Vegetation	771

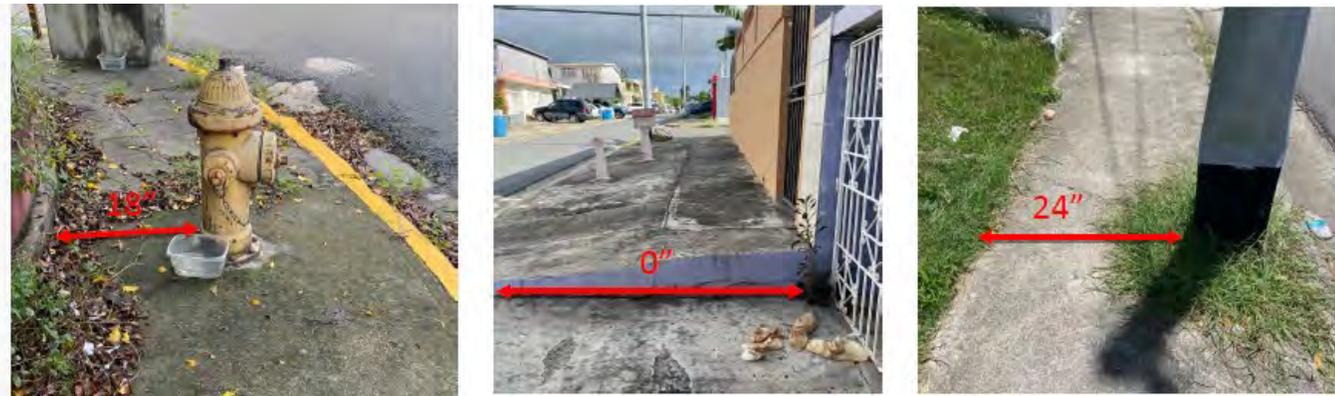
Fixed Pinch Point: Path of Travel is < 36" wide due to hard obstruction

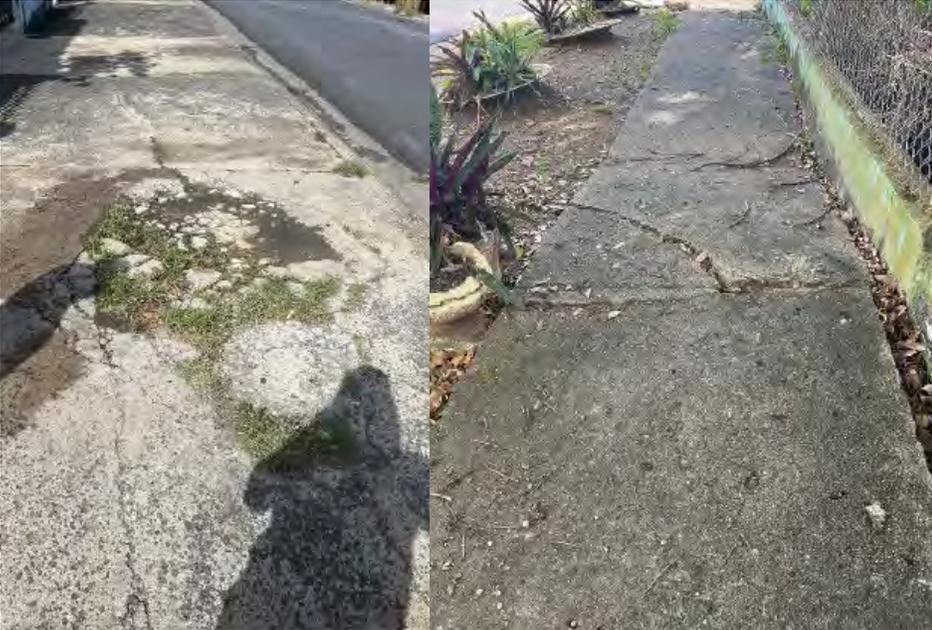
- **8,001 hazards** (<36") identified, measured, and mapped

Stantec determined at least **60%** of total sidewalks do not comply with ADA regulations.
